# **DOE Accident Investigation Program Lessons Learned**

## **Based on the July 28, 1998, Carbon Dioxide Release at INEEL**

Design and installation irregularities in total flooding carbon dioxide (CO<sub>2</sub>) fire suppression systems can lead to a sudden and unexpected lethal discharge of CO<sub>2</sub>.

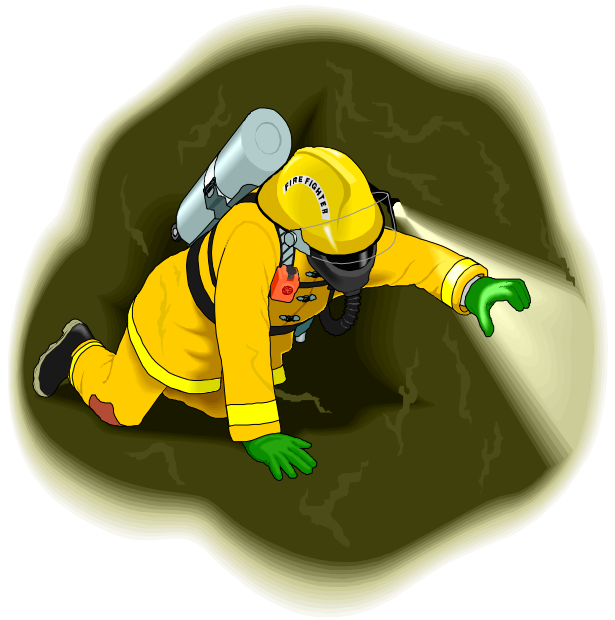
The unexpected activation on July 28 of the high pressure, carbon dioxide fire suppression system in Building 648 at the Idaho National Environmental Engineering Laboratory (INEEL) provided a tragic reminder of the need to hasten the implementation of Integrated Safety Management (ISM). Within seconds, 15 workers found themselves struggling to escape the building, while confronting a potentially lethal and disorienting atmosphere under near zero visibility. The accident caused one fatality, several life-threatening injuries, and a significant risk to the safety of initial rescuers.
